4.0 ANNOTATED LIST OF PROPERTIES

The Annotated List of Properties catalogs all resources reviewed during the field work for the Intensive Level Survey Project for the Village of Brockport.

4.1 CLINTON STREET

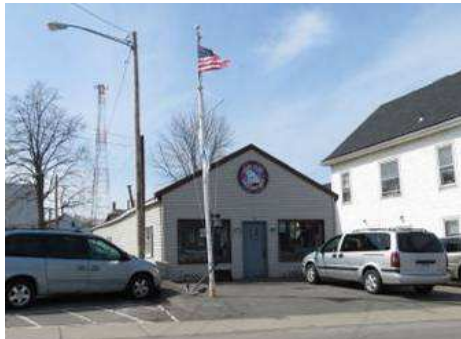
| ADDRESS: 21 Clinton Street | TAX ID: 068.52-4-9 | DATE OF CONSTRUCTION: Ca. 1900 | SIGNIFICANCE: N - significantly altered |

| CONDITION: Good | | NAME: Navy Club Lake Ontario | |
| | | DESCRIPTION: 1-story front gable frame structure; vinyl siding, asphalt shingle roof, metal entry door flanked by large single pane fixed windows. | |

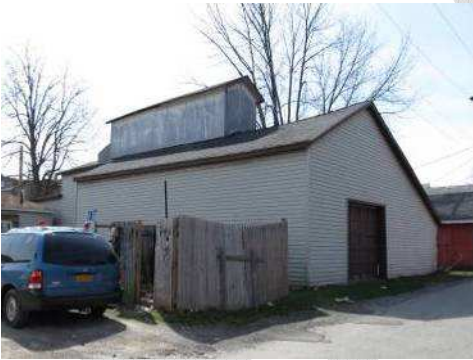
| ADDRESS: 21 Clinton Street Rear | TAX ID: 068.52-4-38 | DATE OF CONSTRUCTION: Ca. 1890s | SIGNIFICANCE: N – significantly altered |

| CONDITION: Good | | NAME: | |
| | | DESCRIPTION: 1-story side gable frame structure building with salt-box type massing; vinyl siding, asphalt shingle roof, no windows, single garage door. | |

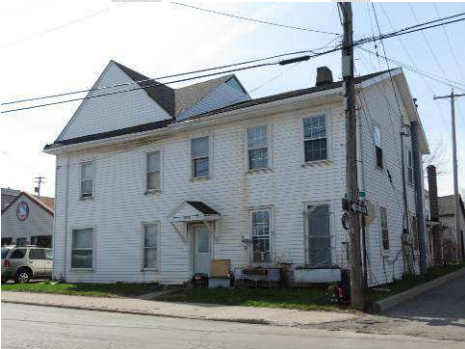
| ADDRESS: 23/25 Clinton Street | TAX ID: 068.52-4-8 | DATE OF CONSTRUCTION: Ca. 1850s | SIGNIFICANCE: N – significantly altered |

| CONDITION: Fair | | NAME: | |
| | | DESCRIPTION: 2-story partially cross gable/partially side gable frame house with suggestions of Greek Revival massing; vinyl siding and asphalt shingle roof. Central entry with bracketed triangular pediment hood, modern entry door, various vinyl window units, including 1/1 and 6/6 simulated divided light units, irregular fenestration. | |

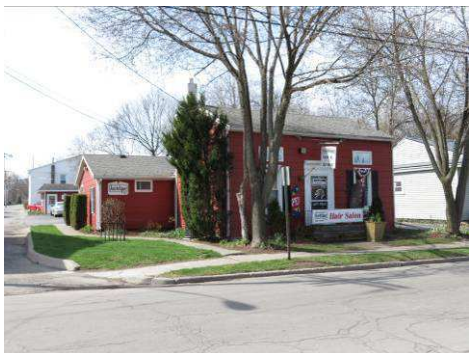
| ADDRESS: 31 Clinton Street | TAX ID: 068.52-4-7 | DATE OF CONSTRUCTION: Ca. 1840s | SIGNIFICANCE: N – significantly altered (NR) Potential local historic district (Canal-era buildings) |

| CONDITION: Good | | NAME: | |
| | | DESCRIPTION: 1-story side gable frame building with modest Greek Revival styling; asbestos siding, asphalt shingle roof. Raised stoop at central entry, modern door, 1/1 vinyl window units. USN 05541.000319 | |

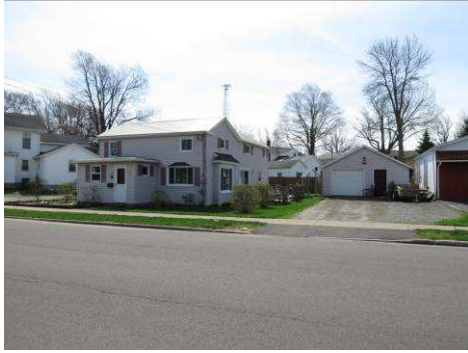
| ADDRESS: 81 Clinton Street | TAX ID: 068.52-3-4 | DATE OF CONSTRUCTION: Ca. 1840 | NR CRITERIA: N – significantly altered (NR) Potential local historic district (Canal-era buildings) |

| CONDITION: Good | | NAME: | |
| | | DESCRIPTION: 2-story side gable frame house with vernacular styling; concrete foundation, vinyl siding, standing seam metal roof. Half-width enclosed shallow hipped roof front entry porch. Various vinyl window types, including 1/1 horizontal sliding. Property includes 2-bay automobile garage. | |

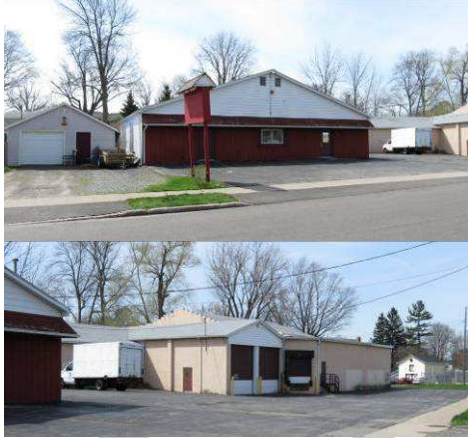
| ADDRESS: 85 Clinton Street | TAX ID: 068.52-3-3 | DATE OF CONSTRUCTION: Ca. 1920s, modern alterations | SIGNIFICANCE: N – not architecturally significant |

| CONDITION: Good | | NAME: | |
| | | DESCRIPTION: U-shaped complex of buildings, including 2-story front gable concrete block constructed building and side-gable block with L-shaped 1-story concrete block connector. Asphalt shingle roof; numerous truck bays. | |

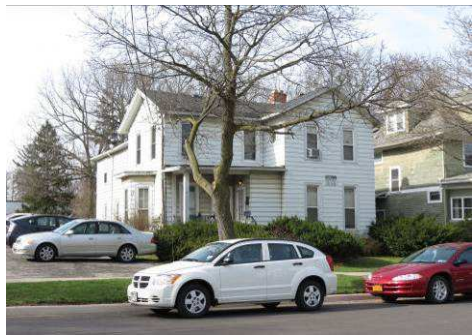
| ADDRESS: 17/19 College Street | TAX ID: 068.68-1-10 | DATE OF CONSTRUCTION: Ca. 1900s | SIGNIFICANCE: N – significantly altered (NR) Potential local College St historic district |

| CONDITION: Good | | NAME: | |
| | | DESCRIPTION: 2-story cross gable frame house with vernacular styling; aluminum siding, asphalt shingle roof, recessed half-width flat roof open porch with square columns and wrought iron railings, 1/1 wood sash double hung windows, porthole window. | |

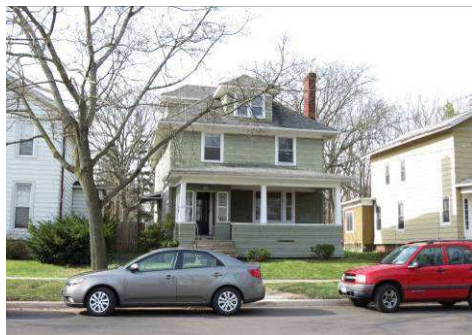
| ADDRESS: 21 College Street | TAX ID: 068.68-1-9 | DATE OF CONSTRUCTION: Ca. 1910s | SIGNIFICANCE: N – not individually signif (NR) Potential local College St historic district |

| CONDITION: Good | | NAME: | |
| | | DESCRIPTION: 2 ½ story hipped roof frame house with Craftsman styling; wood shingle siding, asphalt shingle roof, full width hipped open entry porch with battered columns and solid railings, 1/1 vinyl windows typical, hipped roof dormers. | |

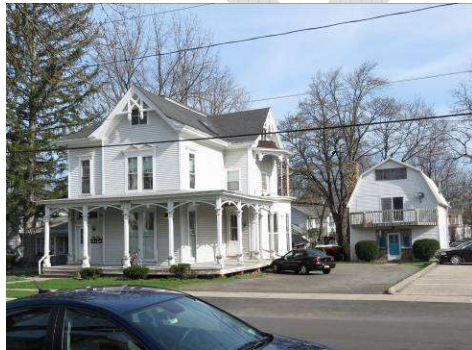
| ADDRESS: 24 College Street | TAX ID: 068.60-6-14 | DATE OF CONSTRUCTION: Ca. 1880s | SIGNIFICANCE: I – Potentially individually NRE Potential local College St historic district |

| CONDITION: Good | | NAME: | |
| | | DESCRIPTION: 2 ½ story cross gable frame house with Eastlake details; wood clapboard, asphalt shingle roof, wrap around open entry porch with square supports pedestals, contemporary entry door, mixture of straight and triangular pedimented hoods above generally 1/1 wood sash double hung windows, decorative bargeboards. Property includes a 1-bay, 2 ½ story gambrel roof barn converted to living space. USN 05541.000335 | |

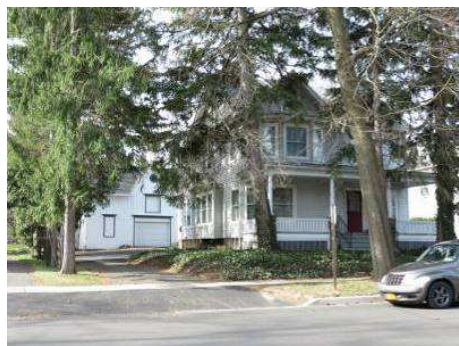
| ADDRESS: 57 College Street | TAX ID: 068.68-1-2 | DATE OF CONSTRUCTION: Ca. 1890s | SIGNIFICANCE: N – not individually signif(NR) Designated local landmark Potential local College St historic district |

| CONDITION: Good | | NAME: | |
| | | DESCRIPTION: 2 ½-story cross gable frame house with Queen Anne styling; raised stone foundation, vinyl siding, asphalt shingle roof. Full-width open entry porch with round columns on stone pedestals and wood railings, wood door with lite, 1/1 double hung windows. 2 nd -story bay window. Property includes large Gothic Revival style barn. USN 05541.000344 | |

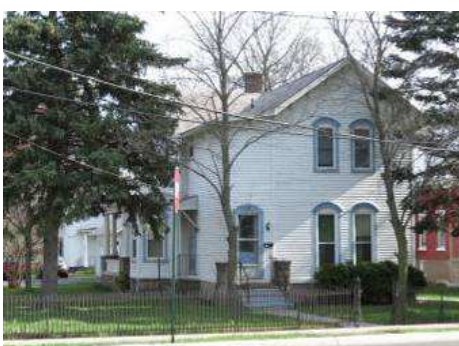
| ADDRESS: 60/62 College Street | TAX ID: 068.60-6-21 | DATE OF CONSTRUCTION: Ca. 1870s | NR CRITERIA: N – significantly altered (NR) Potential local College St historic district |

| CONDITION: Good | | NAME: T.H. Dobson House | |
| | | DESCRIPTION: 2-story cross gable frame house with Italianate styling; raised foundation with concrete, wood clapboard, asphalt shingle roof. Paneled and glazed entry door with segmental pediment, stone piers flanking doorway, 1/1 vinyl window units topped with segmental arch hood molds, bracketed cornice. | |

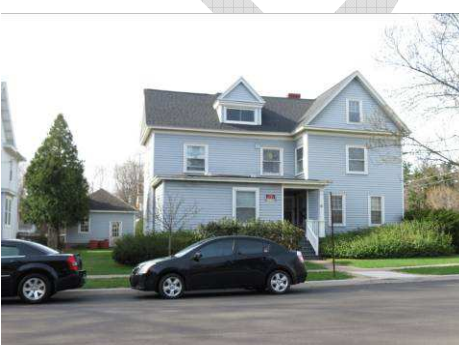
| ADDRESS: 61 College Street | TAX ID: 068.68-1-1 | DATE OF CONSTRUCTION: Ca. 1890s | NR CRITERIA: N –significantly altered (NR) Potential local College St historic district |

| CONDITION: Good | | NAME: | |
| | | DESCRIPTION: 2 ½ story cross gable frame house with vernacular Queen Anne styling; vinyl siding, asphalt shingle roof. 1-bay open entry porch with square column and wood railings, generally 1/1 wood sash double hung windows and some 9/9 simulated divided lite windows. Pent roof at gable end and gable dormer. | |

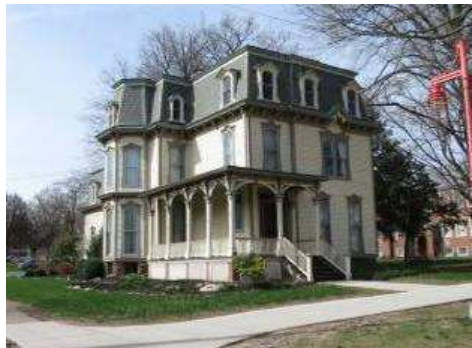
| ADDRESS: 75 College Street | TAX ID: 068.16-1-2 | DATE OF CONSTRUCTION: Ca. 1860s | SIGNIFICANCE: L – Previously NR listed Designated local landmark |

| CONDITION: Excellent | | NAME: Alumni House SUNY Brockport | |
| | | DESCRIPTION: 2 ½-story mansard roof frame house with Italianate styling; raised stone foundation, wood clapboard, slate roof. Half-width wrap-around open entry porch with square supports and decorative brackets, door surround includes transom and sidelites, 1/1 wood sash double hung windows typical with decorative hood molds. Bracketed cornice and gable dormers at mansard roof level. USN 05541.000079, previously determined "L" Listed by SHPO | |

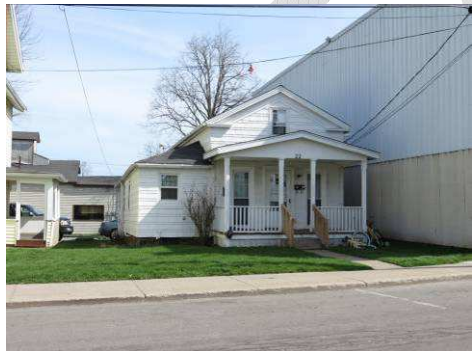
| ADDRESS: 22 King Street | TAX ID: 068.52-4-26 | DATE OF CONSTRUCTION: Ca. 1840s | SIGNIFICANCE: N – not individually signif. (NR) Potential King Street local district |

| CONDITION: Good | | NAME: | |
| | | DESCRIPTION: 1 ½-story front gable with wing frame house with Greek Revival styling; stone foundation, wood shingle siding, asphalt shingle roof. Half-width open entry porch with pediment, square chamfered supports, wood railing, contemporary door, Windows are generally 1/1 vinyl units. 6/6 vinyl window units flank front door. Cornice returns at gable end. | |

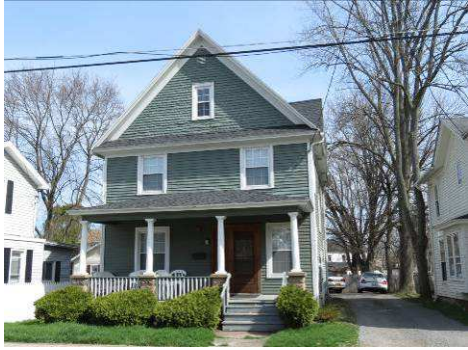
| ADDRESS: 58 King Street | TAX ID: 068.52-4-35 | DATE OF CONSTRUCTION: Ca. 1890s | SIGNIFICANCE: N – not individually signif. (NR) Potential King Street local district |

| CONDITION: Good | | NAME: | |
| | | DESCRIPTION: 2 1/2-story front gable house with modest Queen Anne styling; stone foundation, wood clapboard, asphalt shingle roof. Full-width open entry porch with round fluted columns atop stone piers, wood railings. Historic double entry door. Windows mostly 6/6 simulated divided lite vinyl units with irregular fenestration. Pent roof, shingles and 4/4 simulated divided lite vinyl window, and shingle siding on gable end | |
